LAKES OF DELHI

PROJECT: GHEWRA-A WATER BODY, GHEWRA VILLAGE

CLIENT
National Environmental Engineering
Research Institute [NEERI]

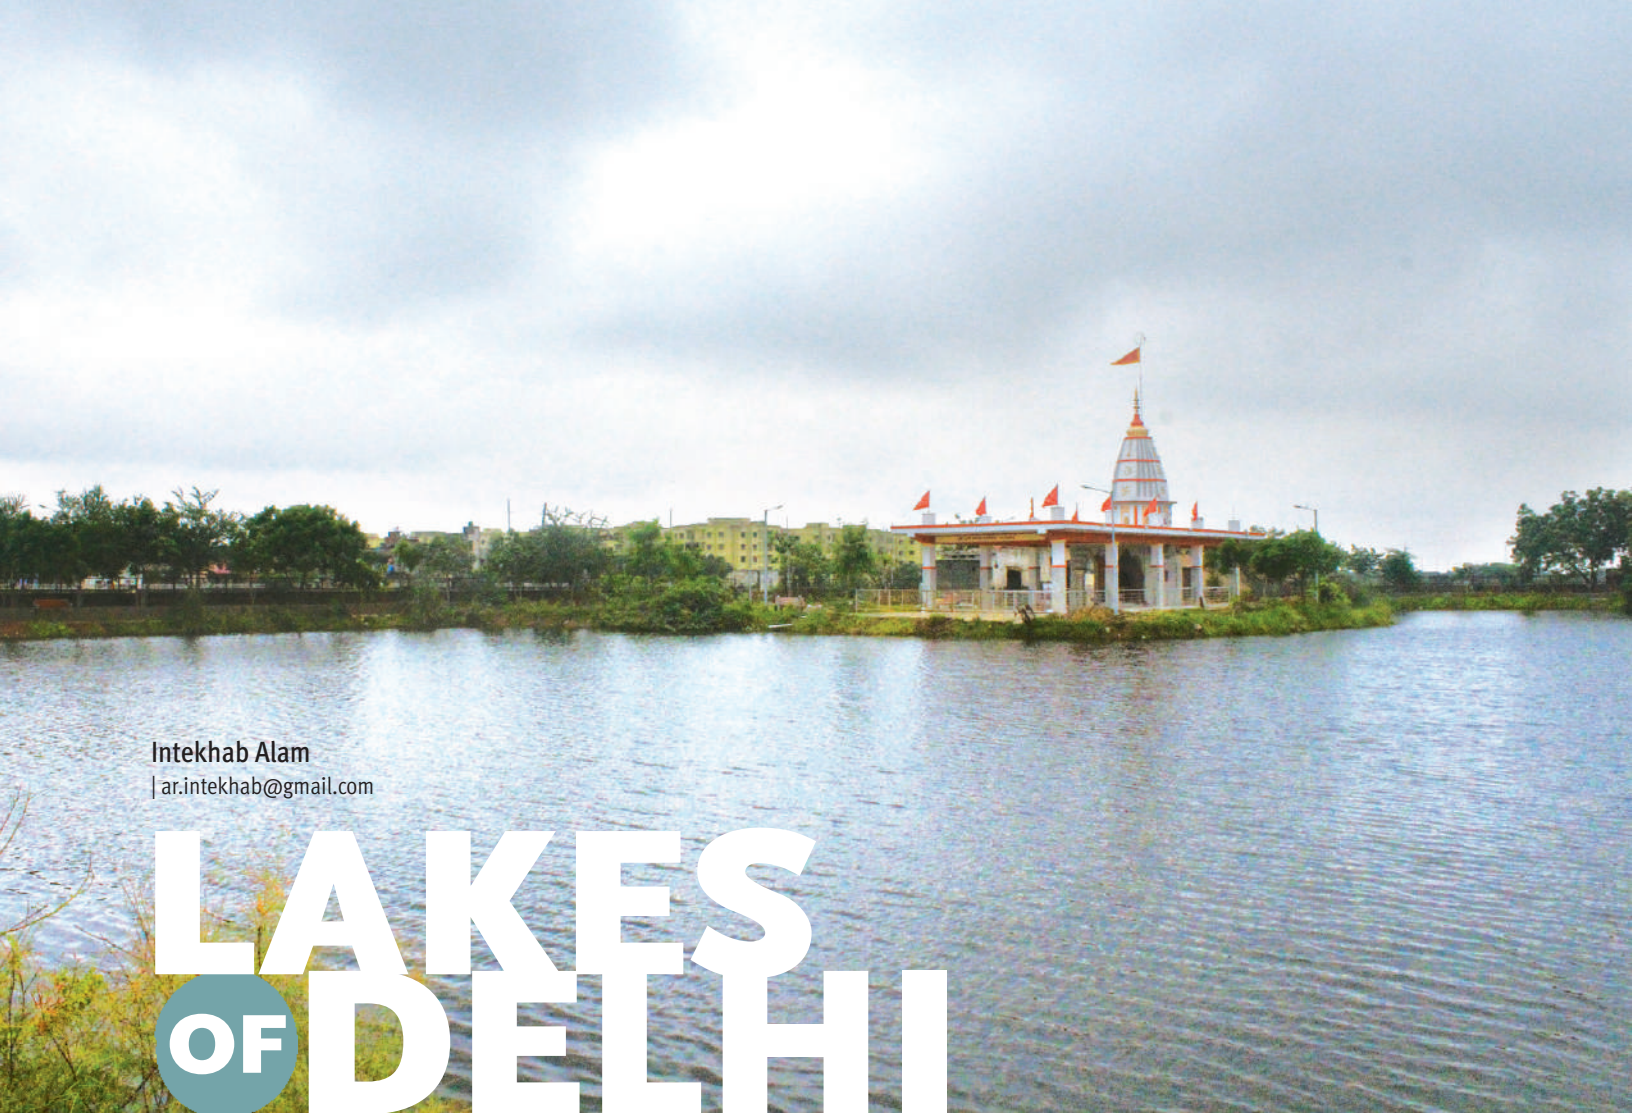
↑ THIS PAGE

The lake [johad] near Bakkarwala village lies outside the abadi area. With a temple near by, the water is used for rituals and is comparatively cleaner all through the year.

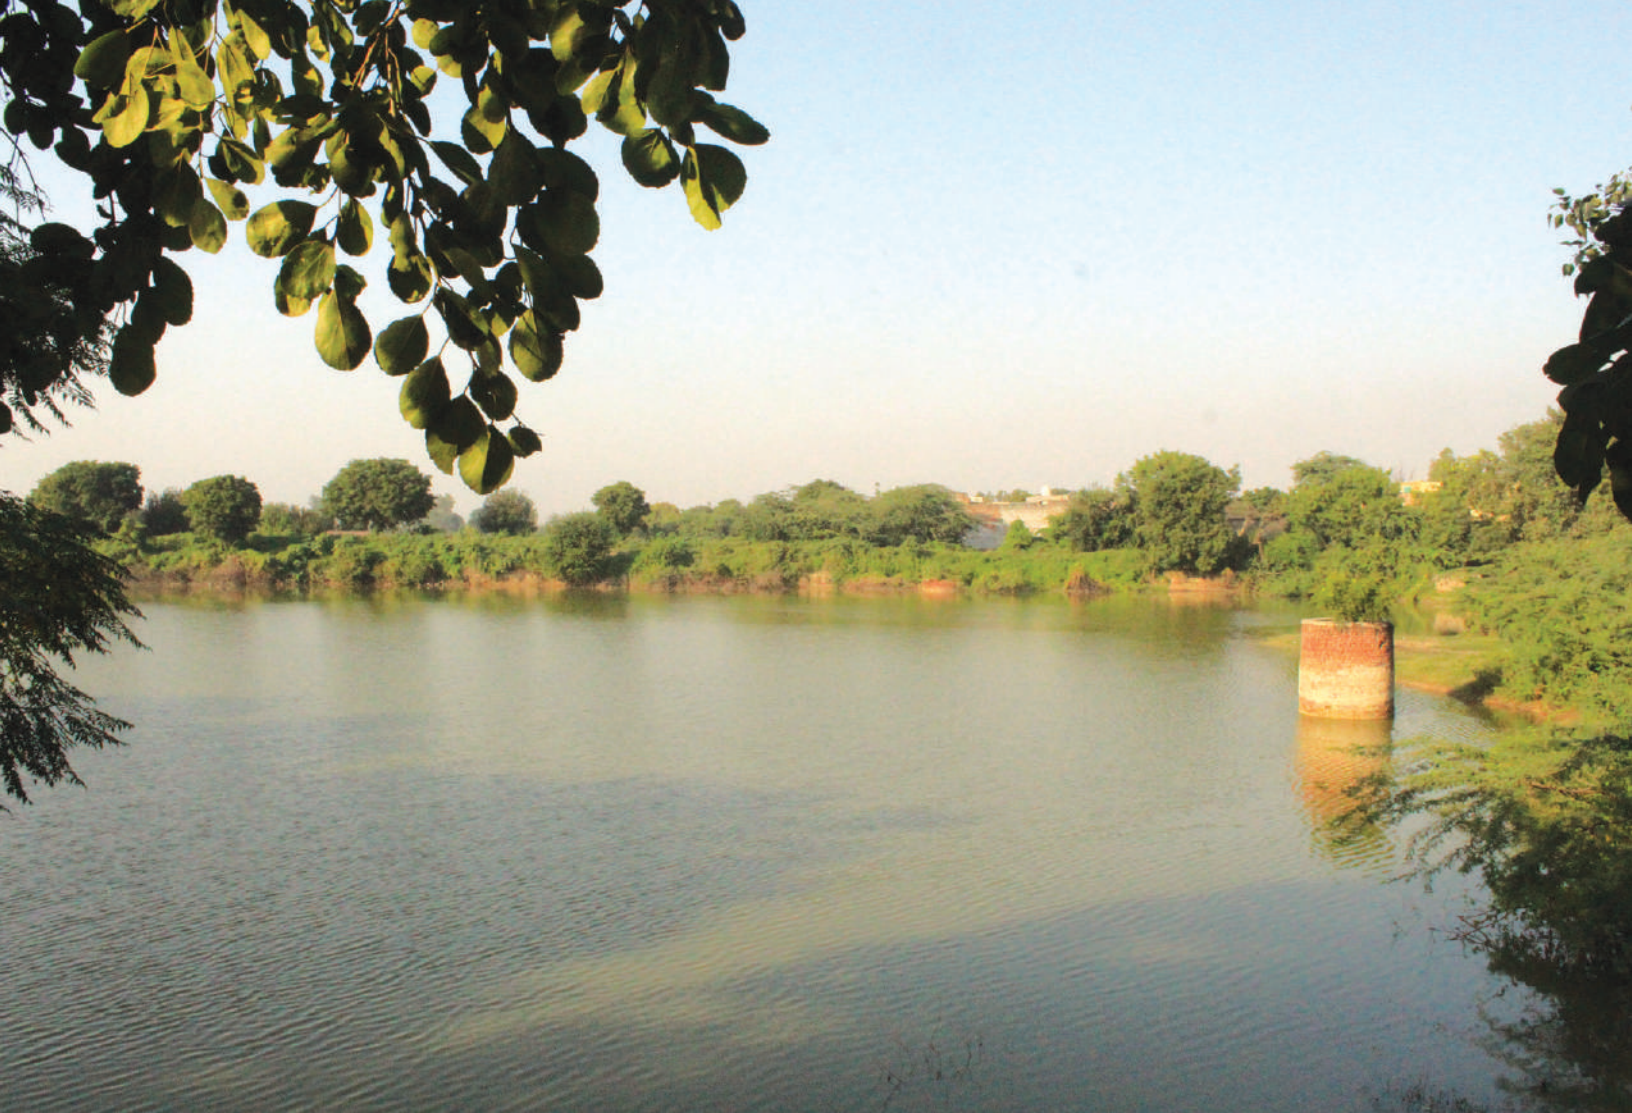
↗ FACING PAGE

The lake of Mohammadpur Majri lies adjacent to the abadi area. It is quite large and attracts several birds. The water also is used for bathing cattle.

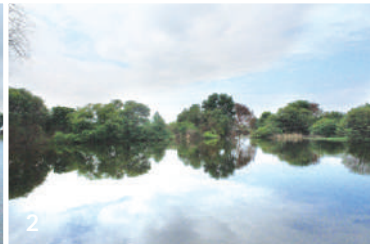
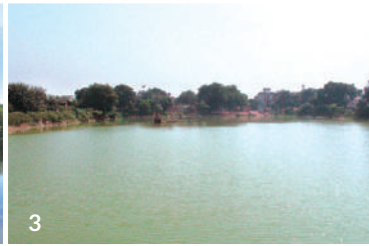
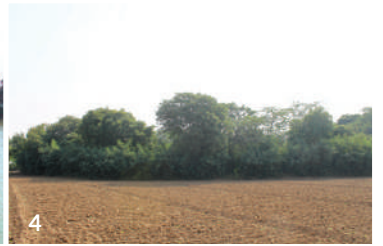
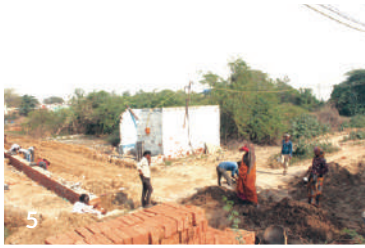
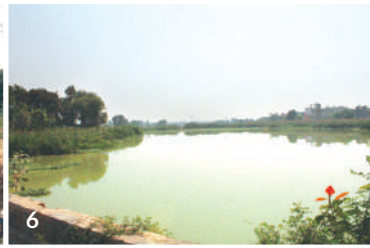
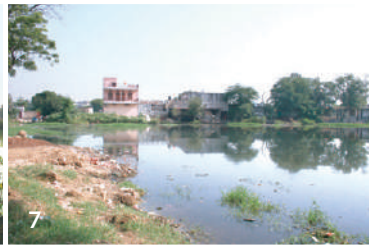
3. Boundary Conditions (Boundary of proposed site)			
General Description: There is no fencing around the water body. Only recently one small stretch of boundary wall was erected to stop the water coming towards the village area.			
		Height	Material
Condition 1	1.5 m	Concrete wall and steel railing on top	Due to contact with water, the boundary wall is getting damaged at the bottom
Condition 2	3 m	Concrete wall and steel railing on top	MCD School boundary

6. Water Levels Assumed			
High Flood Level (m)		0.5	
Water Level (m)		NA	
Water Table (m)		NA	
7. Water Body Bed			
Not lined			
8. Water Body Edge Condition:			
General Description: The periphery/ edge of the water body is not lined. The southern edge is defined by a concrete boundary wall of the MCD School. At one location, a concrete road has been made within the line of the water body.			
		Soft/ Hard	Material/Surface
Condition 1	Hard	Concrete road	Residents have encroached on the water body by making a concrete road at site access point.
Condition 2	Hard	Boundary wall	Boundary walls of MCD School and adjacent homes
Condition 3	Soft	Solid waste, cow dung, soil	Left over spaces around the site

11. Built Structures on Site (Temporary & Permanent)			
No. of Structures: 04		General Description: There are structures at the periphery of site in the form of built permanent road or temporary cow shed structure.	
Structure 1	Road	Encroached concrete road, damaged in some parts	
Structure 2	Well	Stone wall well near access no-02, the structure is said to be very old as told by villagers and needs repairs	
Structure 3	Cow Shed	Temporary cow shed made of asbestos sheet with wooden pillars for support	
Structure 4	Cow Shed	Temporary cow shed made of asbestos sheet with wooden pillars for support

12. Activities on Site			
		General Description: Due to poor condition of the water body and lack of any access, people are not using the water body for recreational purpose. Water is used for bathing of cows.

13. General Observations:			
		Planned access on all sides is required to ensure upkeep and maintenance of the water body. Limited opportunities exist for landscape development. However, approach roads/ streets to the water body and edge conditions can be substantially

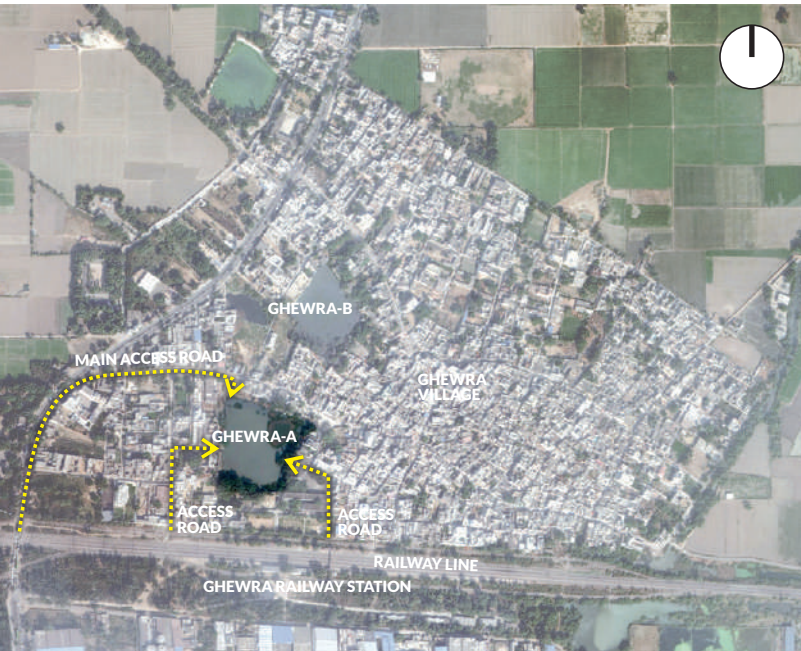
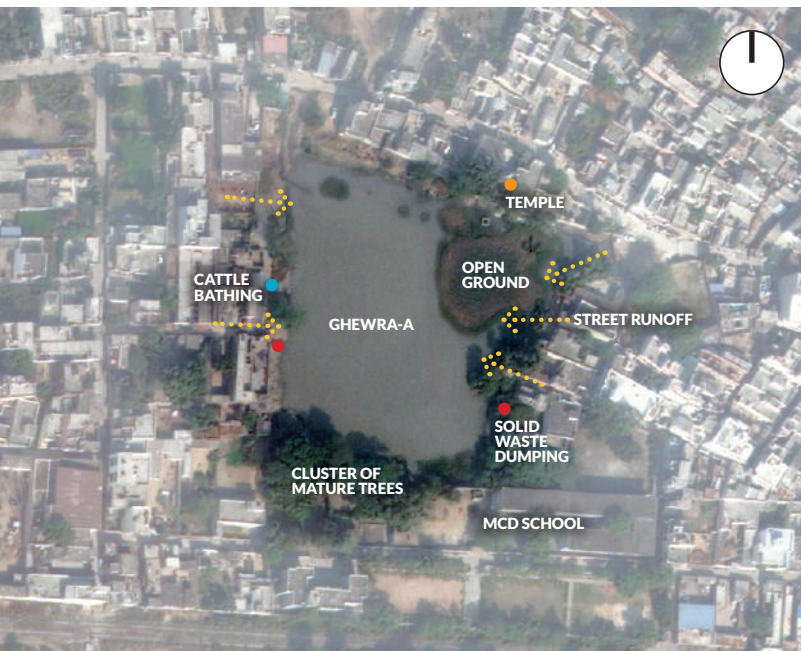
→ SITE INVESTIGATION AND DOCUMENTATION PROFORMA

The survey of the water body included various important aspects – Site area, onlets of water bodies with assumed levels, character of lake bed, lake edges, issues, status of surrounding flora and fauna, surrounding temporary and permanent structures and activities on site

SITE INVESTIGATION AND DOCUMENTATION PROFORMA		WATER BODY NAME: GHEWRA-A	
Khasra No.: 223, 223/1		Date of Site Visit: 20/09/2018	
		Time of Site Visit: 9:00 am	
		Visit conducted by: Intekhab Alam, Mriganka Saxena	
		District/ Town/Village: West Delhi/ Gherwa	
		Site Coordinates: 76° 59'50.51"E/ 28° 41'35.47"N	
		No. of water bodies in the town/village: 03

1. Proposed Site Area (Water body and adjacent and where restoration works may be planned)		Total Site Area(sq.m): 14,985 (source: Google earth)	Area of Water Body (sq.m): 14,288 sq.m (source: Google earth)
		Area of adjoining lands for landscape development (sq.m): 697 sq.m

2. Access			
General Description: The water body is located towards the south-west in Gherwa. Houses are built to the edge of the water body giving no or very little space to access it. There are two streets which lead to the water body and one open access to the north. There are no pathways etc: even on the periphery.			
No. of access roads/ streets to the site: 03			
Are these gated/ non gated? Non-gated			
No. of planned access points into the water body, if any, and their description: None

4. Water Body			
Status: Wet		General Description: Remains wet throughout the year.	
Area (sq.m): 14,985			
Perimeter (m): 588			
Assumed Depth (m): 2.5-3.0			
Surveyed Depth (m): NA			
Assumed Volume (cum.): 37470 approx

5. Inlets			
No. of Inlets and Inlet Structure		Details: Waste water from the village flows in the storm-water drains along the streets, finally falling into the water body. Cow dung also comes in the water body directly from the dairy farms located immediately adjacent and from those in the surrounding neighbourhood.	
Inlet 5	Open Drain Channel	Cemented storm water drain along access road	
Inlet 5	PVC Pipe	Direct drain from adjoining homes	
Inlet 5	Open Drain Channel	Cemented storm water drain along access road	
Inlet 5	Open Drain Channel	Cemented storm water drain along access road	
Inlet 5	PVC Pipe	Direct drain from adjoining homes

9. Solid Waste			
General Description: Primarily unsegregated domestic waste and cow dung			
Number of solid waste dumping zones: 03		Description (Extent & Type)

10. Vegetation			
Vegetation on Site			
General Description: Vilayati keekar is grown widely on site, there are few peepal and neem trees also near access roads			
Trees (Number & Type)		20-22, native type	
Shrubs- Description		Native shrubs are growing widely in some part of the pathway	
Grasses- Description		Wild grasses could also be seen on the edge of water body especially near MCD School	
Vegetation in Water Body			
General Description: Reeds and grasses are seen at certain locations			
Grasses/ Shrubs- Description

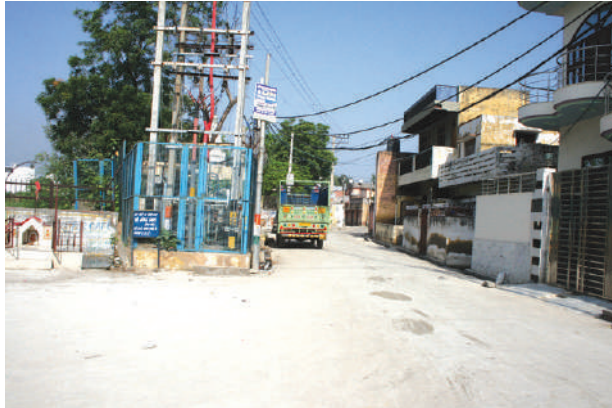
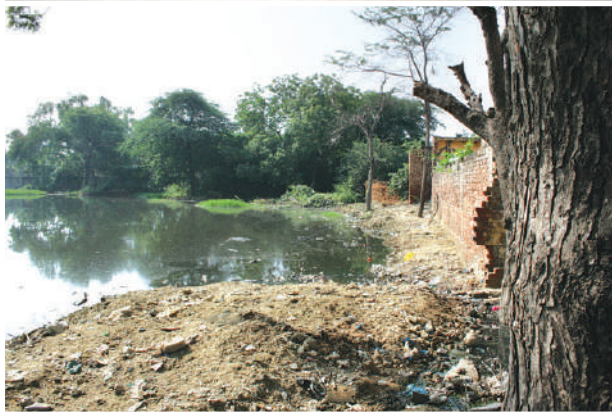
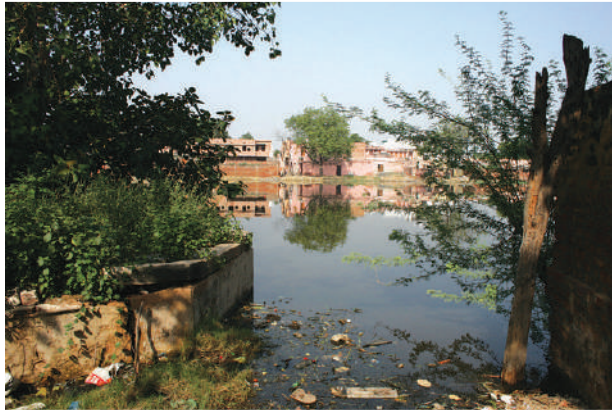
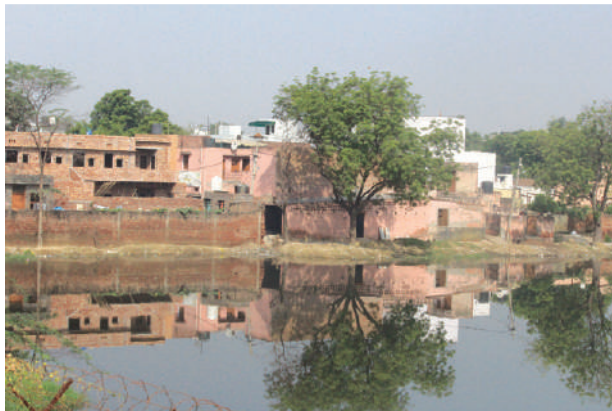
LEFT [TOP TO BOTTOM]

- ← In Ghewra village, the lake is not visible from the main access road. Unless one asks the villagers, it is difficult to locate it from outside
- ✓ The main access to the lake has been reduced to a solid waste disposal unit
- ✓ The lake carries all the waste water and storm water of abadi area
- ✓ View looking towards west from school building towards the lake

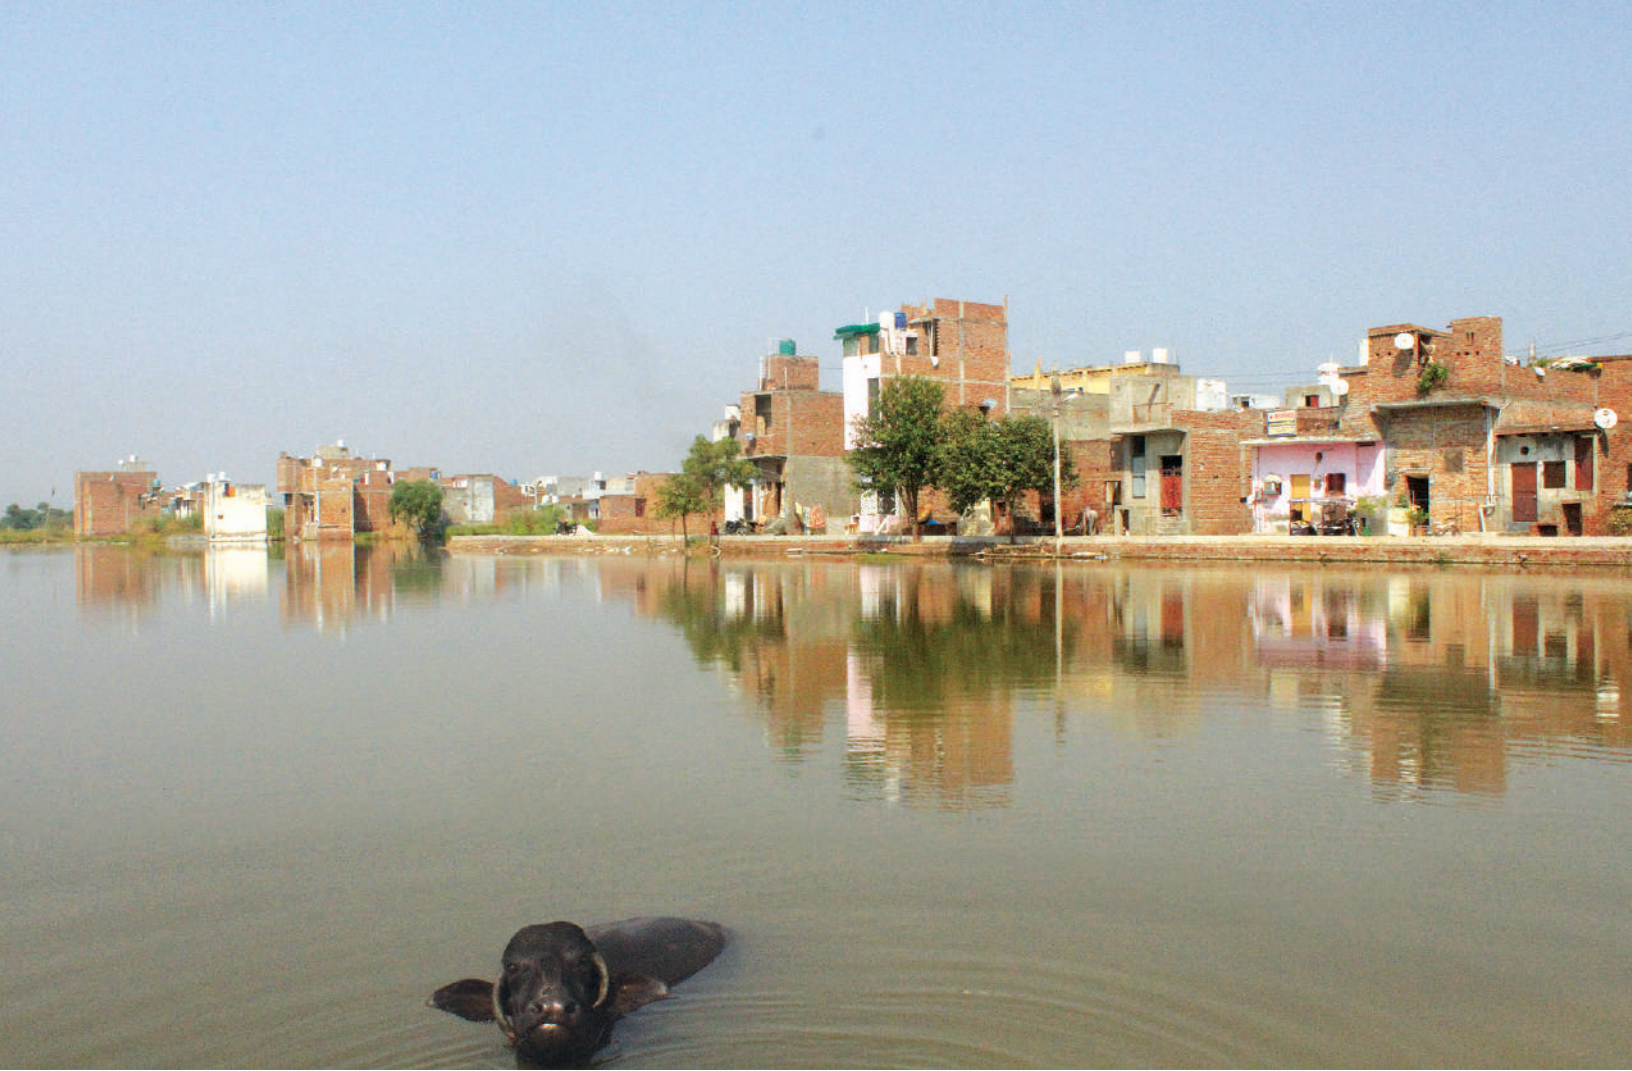
↑ *Water body at Mohammadpur Majri*
