GLUECHEK

How it Works

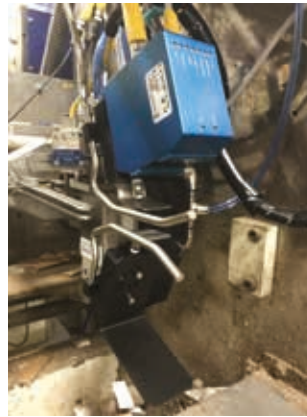
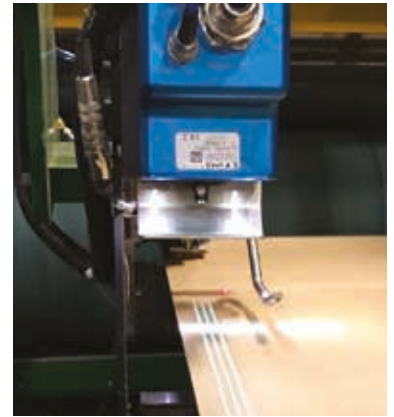
GlueChek™ takes a picture of every glue tab. The system analyzes the glue pattern to ensure that no gluing problems exist. When a gluing problem is found, GlueChek™ notifies operators by alarm, then marks the defective box and saves an image of the gluing problem.

Bad Glue Joint Examples

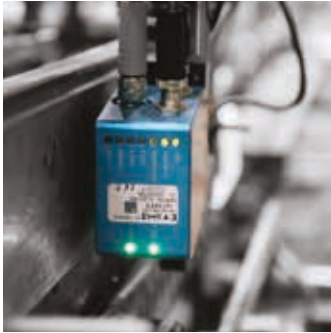
Narrow

- Small footprint
- Simple to move and install
- Self-calibrating
- Ideal for single glue line or DOT applications
- Field of view 60mm wide

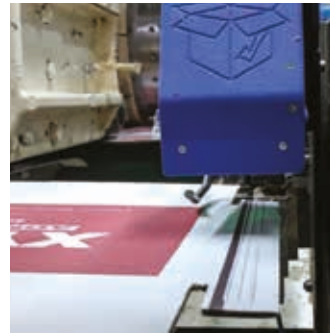
Shadow

- Built-in lighting source
- Designed to create profile or shadow to define raised edges.
- Ideal for braille, glue patterns, tip-ons and more
